# PETER BARTEN HOME INSPECTIONS

## INSPECTION REPORT

4040 Mina Ave  
Depoe Bay, OR 97341

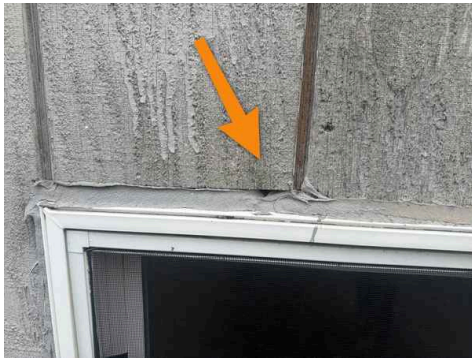
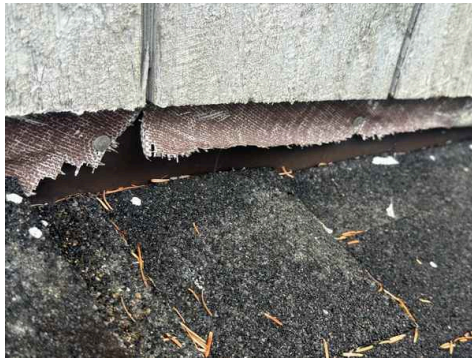
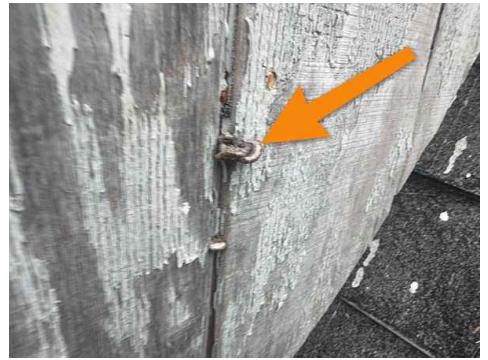
Damaged siding and trim was observed at various locations. Also poor installation details and neglect was observed at multiple locations. The extent of damage was not determined. Call a qualified professional to make further evaluation and repairs as needed.

Mushrooms growing out of failed/neglected siding

Contact a qualified professional.

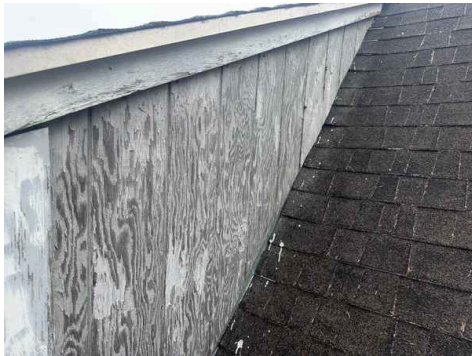
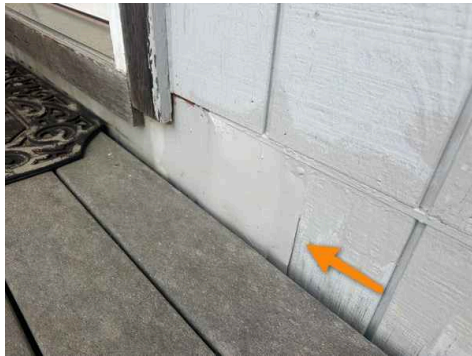
Improper installation/flashing

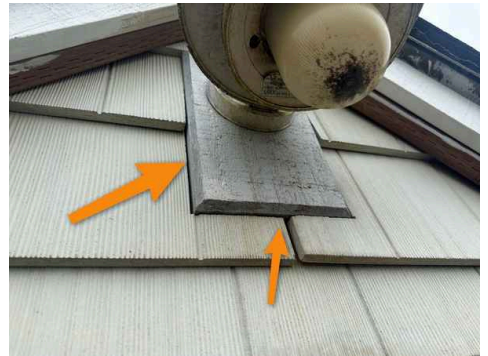
Poor installation: not sealed

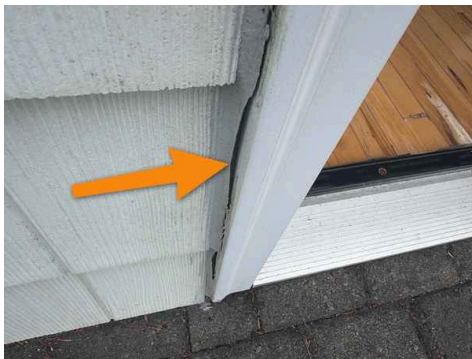
Failed caulking

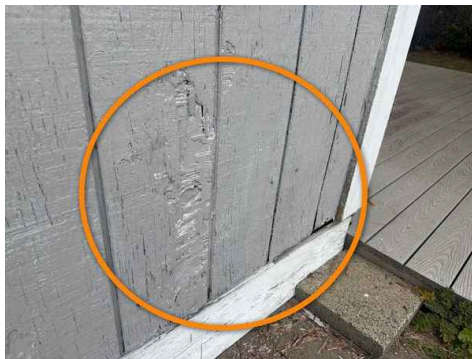
Failed/neglected siding

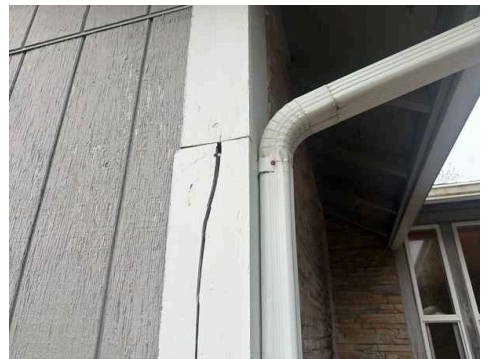
Damaged trim

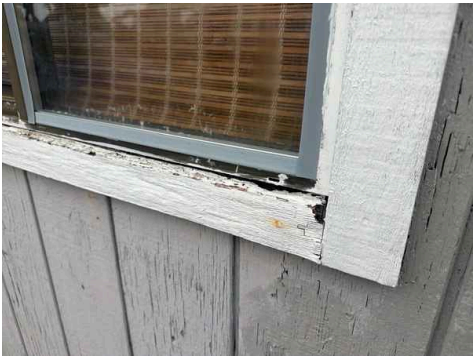
Failed/damaged siding and trim

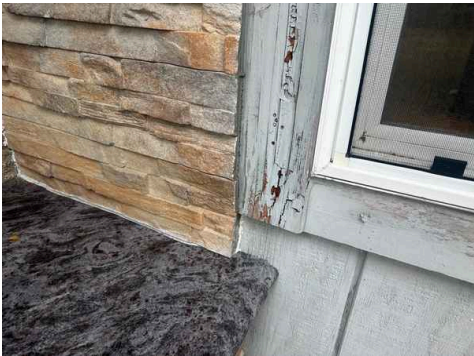
Rotted siding/improper manufactured masonry veneer installation

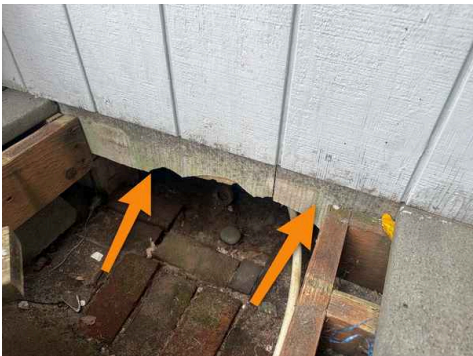
Old fiber cement siding is present under some of the T1-11 siding. The extent of this fiber cement siding present was not determined. Fiber cement siding materials manufactured before the 1980s may contain asbestos fibers. Asbestos poses a health risk if fibers become airborne during disturbance, removal, or deterioration. A qualified environmental professional should perform testing to determine if asbestos is present. If confirmed, specialized abatement contractors must handle any removal or repair work.

Fiber cement siding (Possible asbestos)

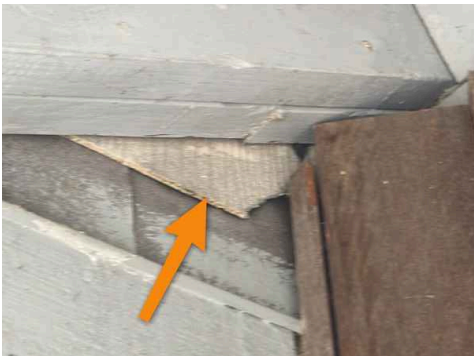
Fiber cement siding (Possible asbestos)

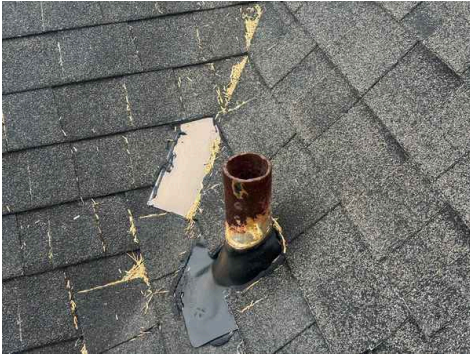
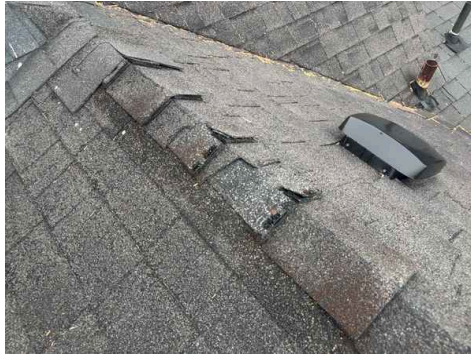
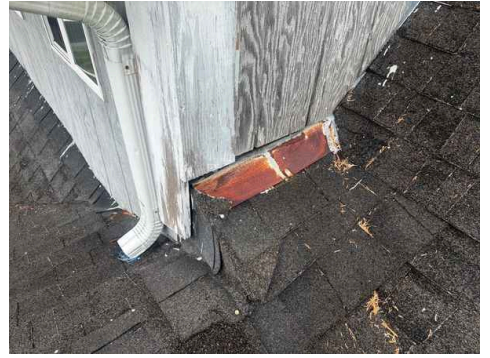
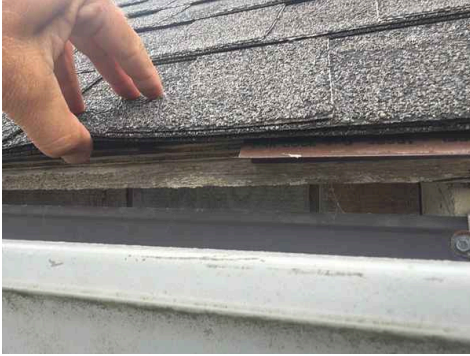
The roof is in marginal condition due to overall age/wear and especially poor installation. Numerous stains throughout the home give evidence for a history of leakage. Replacement is needed now. The potential for hidden damage/rot/mold exists from leakage history.

Contact a qualified professional.

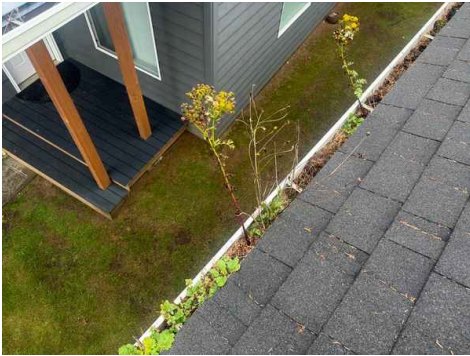
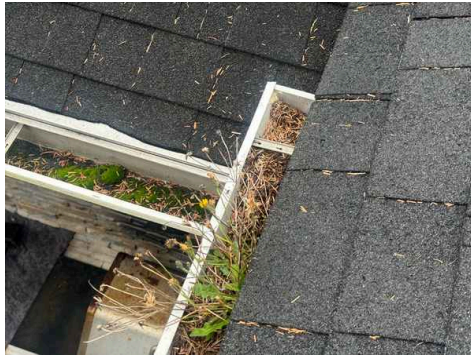
### 5.3.1 Roof Drainage Systems

Debris has accumulated in the gutters. Recommend cleaning to facilitate water flow and proper roof/site drainage.

Contact a qualified handyman.

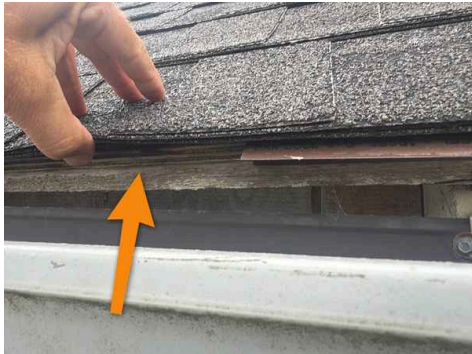
Missing flashings at numerous locations. This increases the likelihood of water penetration and is a sign of substandard/poor installation of the roof/components. Call a roofing professional to make further evaluation and corrections as needed. Based on the poor condition of the roofing material and other substandard installation issues as well as signs of a history of leakage the roof and all related roof components should be replaced.

Incomplete/missing drip flashing

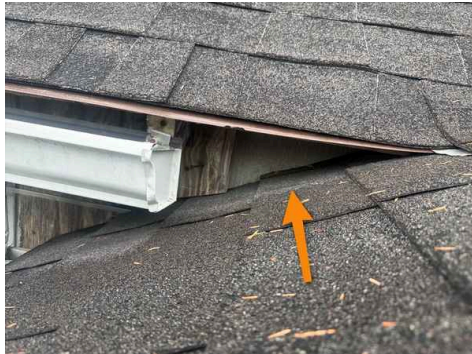
No step flashing

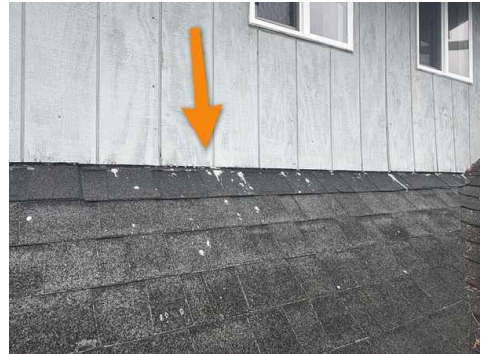
No apron flashing

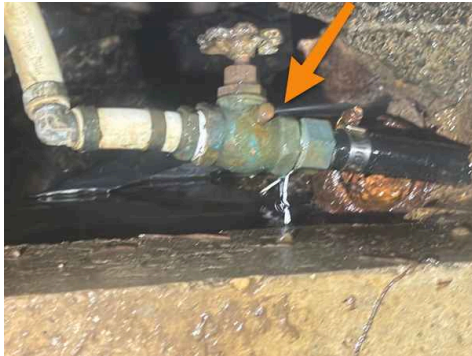
Active leakage was observed at the plumbing supply piping. Call a plumbing contractor to make further evaluation and repairs as needed.

Significant active leakage

Contact a qualified plumbing contractor.

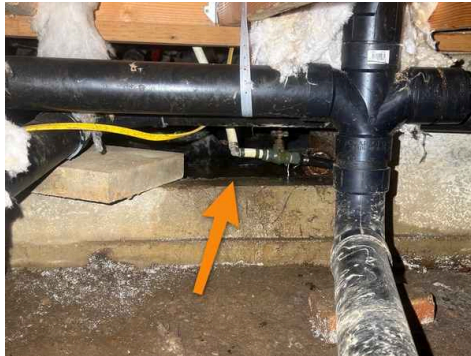
A large pool of standing water is present under the home: this can cause damage/rot/mold. Further evaluation is needed.

Pooling water under home from significant leakage

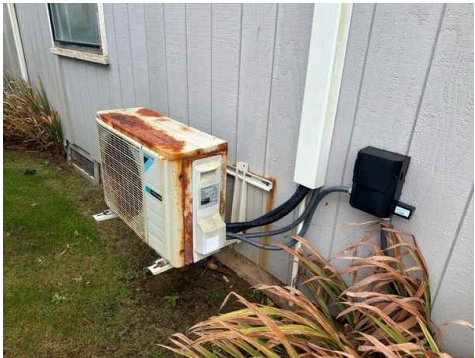
Rust/corrosion was observed at the heat pump. Call a qualified HVAC contractor to service/repair as needed.

Major rust/corrosion

Recommendation  
Contact a qualified professional.

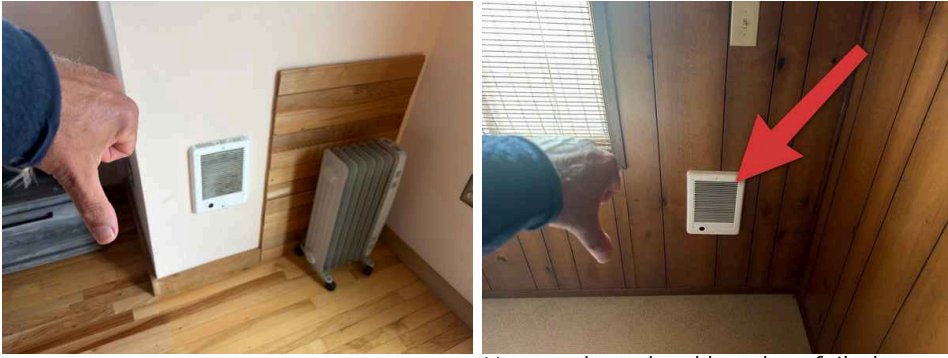
The heater in the downstairs south bedroom turned on with a wall switch and then glowed red hot until it switched off/failed with the fan never engaging. This is a fire hazard. Call a qualified professional to make further evaluation and repairs as needed.

Heater glowed red hot then failed

Recommendation  
Contact a qualified professional.

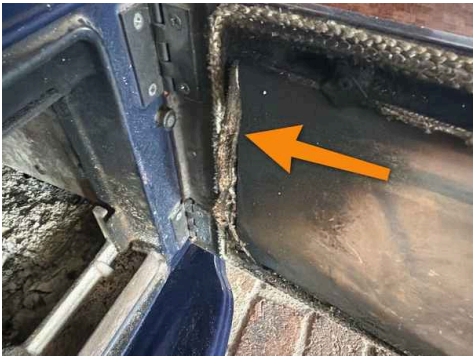
The door/glass seal is falling out and may need to be repaired or replaced.

Contact a qualified professional.

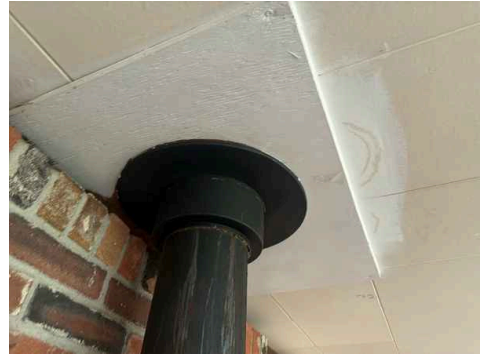
9.2.1 Vents, Flues & Chimneys

Stains near the chimney indicate a history of leakage/water penetration. The potential for hidden damage exists. Further evaluation is recommended.

Contact a qualified professional.

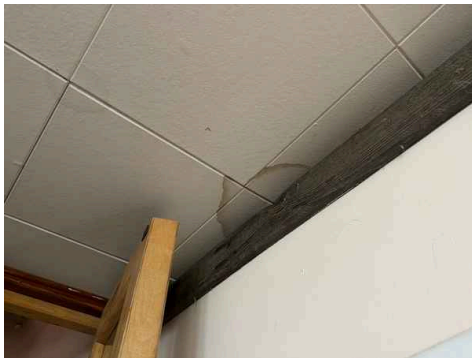
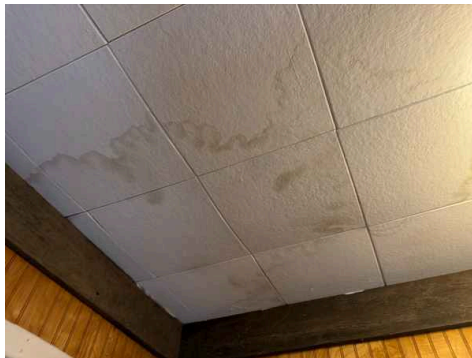
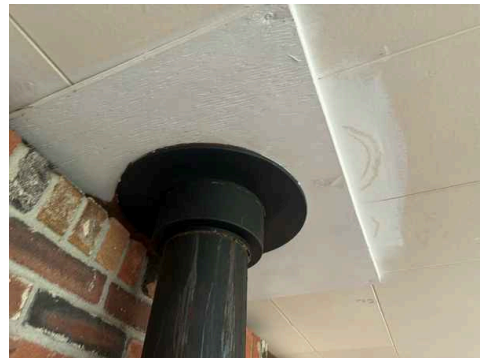
Stain(s) at the ceiling indicates a history of leakage. Source of staining should be determined. The potential for hidden damage exists.

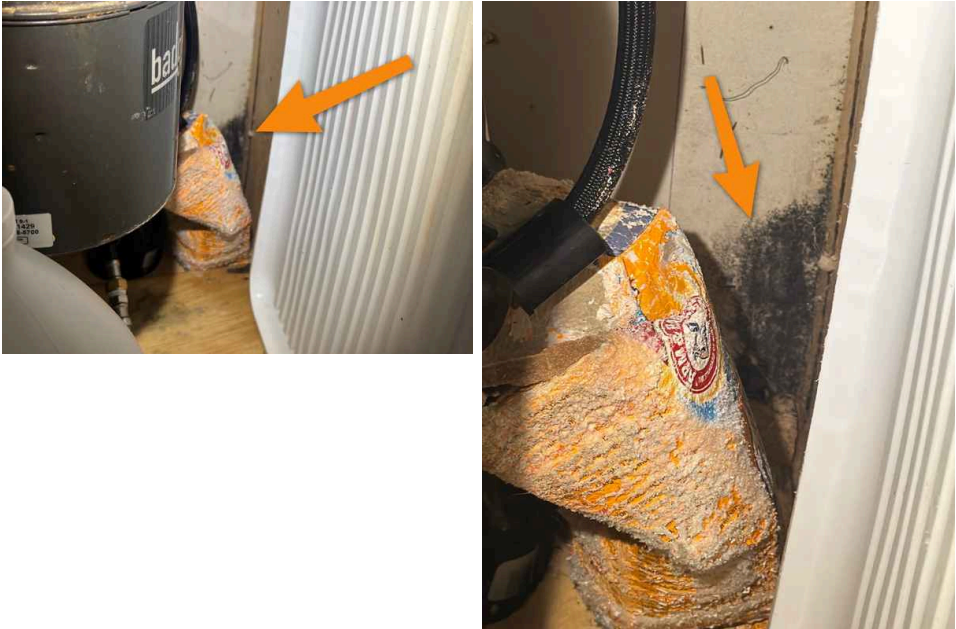
History of leakage was observed under the sink. Damaged cabinet walls/floor noted. Black mold growth was observed. Call a qualified professional to make further evaluation and repairs as needed. The extent of mold growth was not determined.

Contact a qualified professional.

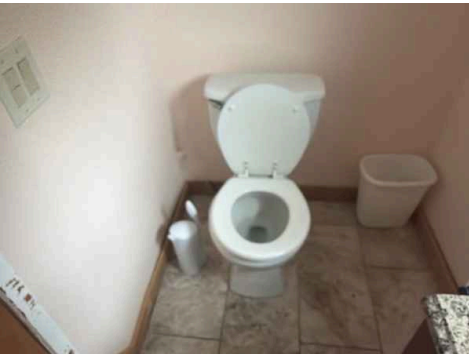
The toilet is loose at the floor: the potential for leakage, damage and mold exists. Call a licensed plumber to make further evaluation and repairs.

Toilet: loose at floor

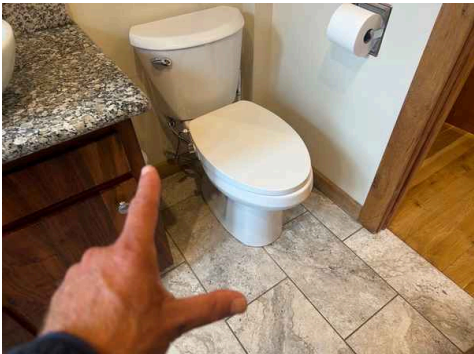
Toilet: loose at floor

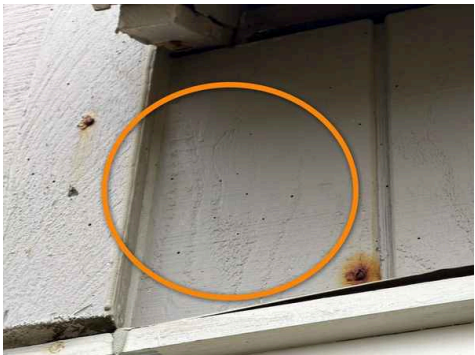
Wood boring beetle exit holes at T1-11 siding

Contact a qualified pest control specialist.
